Subject: EPA Inspection Report

**CWA COMPLIANCE EVALUATION INSPECTION REPORT
U.S. ENVIRONMENTAL PROTECTION AGENCY, REGION 5**

Compliance Evaluation Sampling Inspection

FOIA Ex. 6
(Personal) Farms, LLC
FOIA Ex. 6 (Personal Privacy)

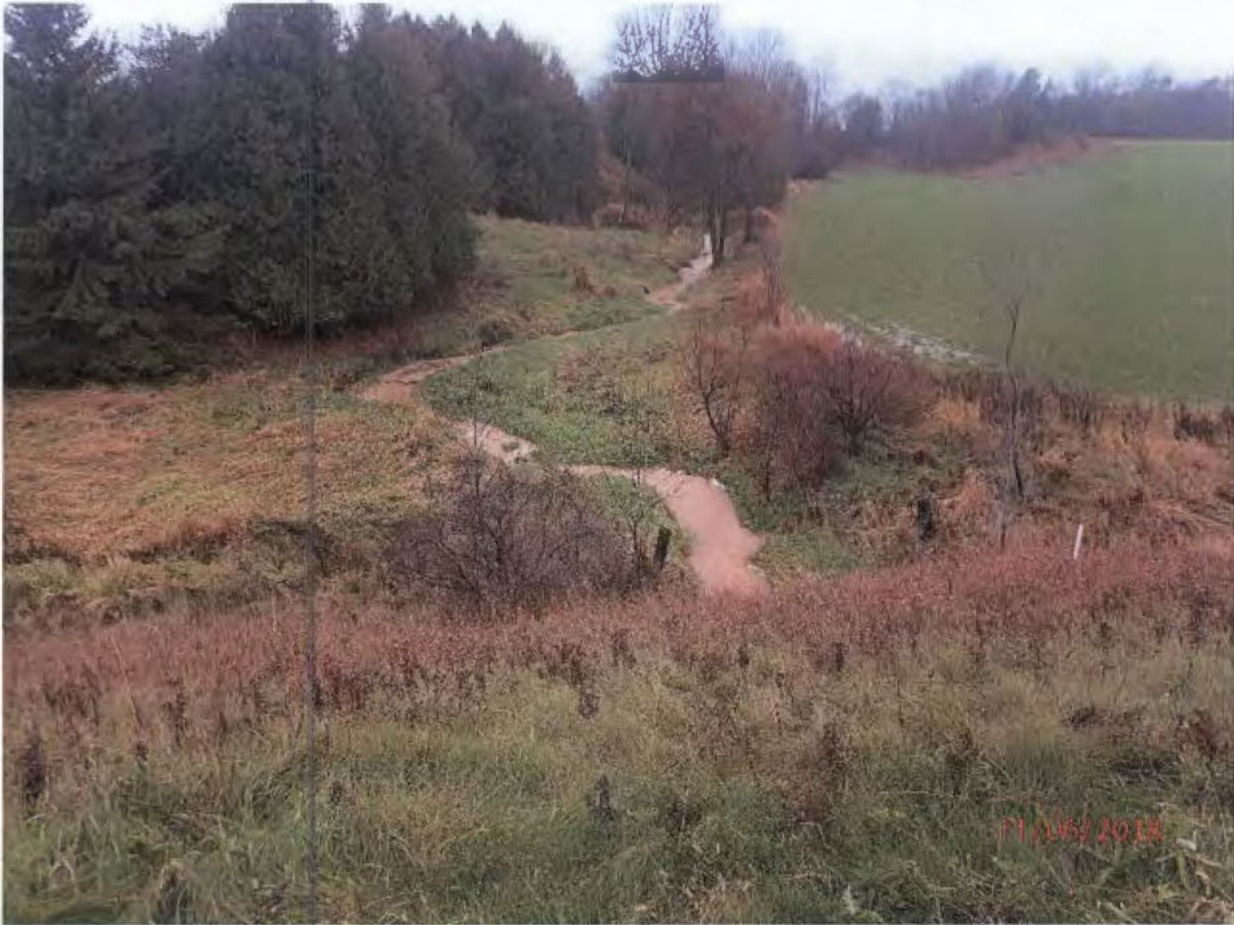
1: PB060003

EPA observed the intermittent unnamed tributary where it flowed under Highway 42 east of the facility. EPA documented that there was flow in the tributary on the day of the inspection.

Description: Looking upstream at intermittent unnamed tributary that flows under Highway 42. There is plenty of flow in the tributary.

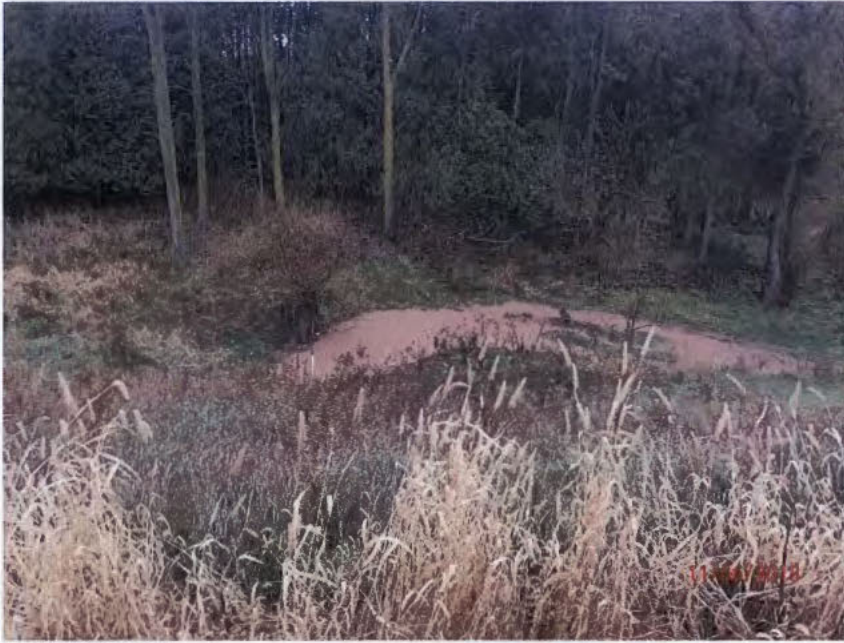
2: PB060004

Description: Looking downstream at intermittent unnamed tributary that flows under Highway 42. There is plenty of flow in the tributary.

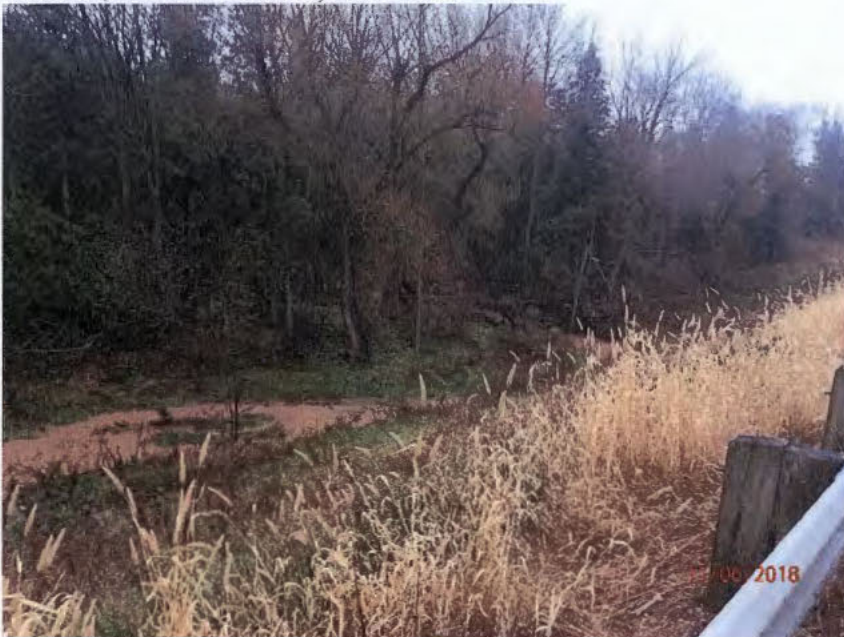
3: PB060005

Description: Looking downstream at intermittent unnamed tributary that flows under Highway 42. There is plenty of flow in the tributary.

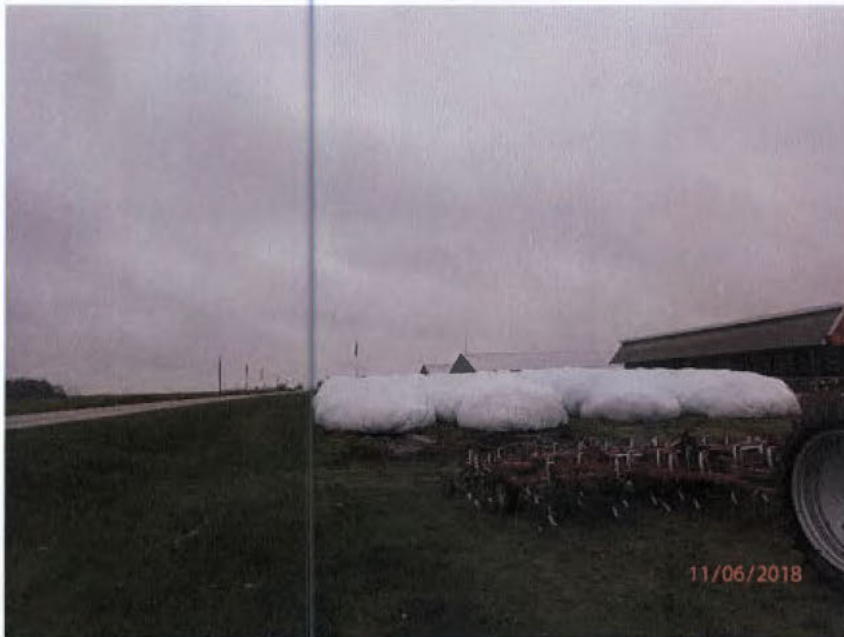
4: PB060006

Description: Silage bags along Sandy Bay Road.

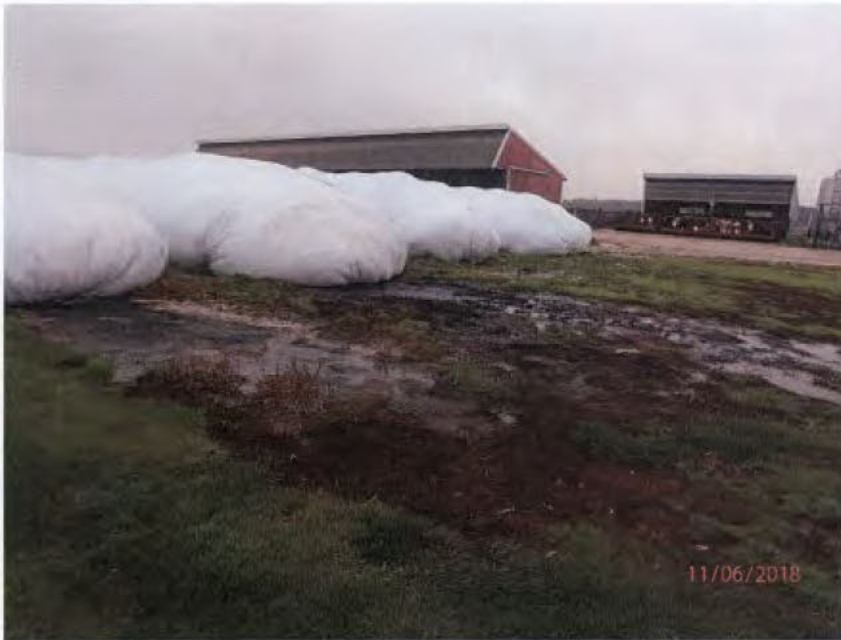
5: PB060007

EPA observed silage leachate on the ground on the east side of the silage bags along Sandy Bay Road and south of the Open Front Heifer Barn. The vegetation on the ground appeared to be nutrient burned. Just to the east of these silage bags, there was a black pipe surrounded by rocks. One end of the pipe was buried in the rocks and the other was open. During the records review after the walk-through, the facility owner stated that the black pipe was a storm water inlet pipe. If silage leachate flows with precipitation to the rocks and seeps into the black inlet pipe, and if the outlet of this pipe was at the intermittent unnamed tributary, then this would be a discharge of pollutants. EPA did not document the location of the black pipe outlet.

Description: Leachate from silage bags has burned the vegetation and has formed puddles of leachate on the ground.

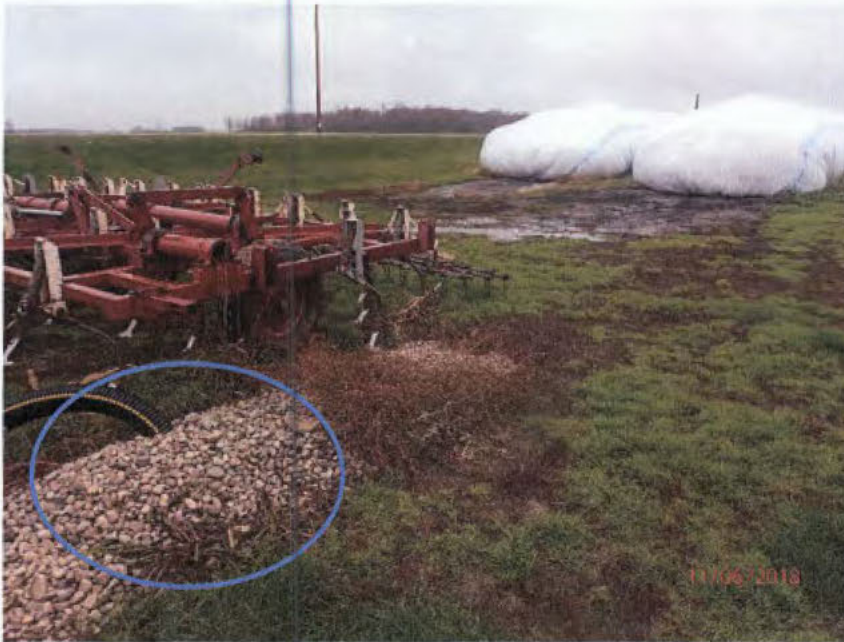
7: PB060009

Description: Silage leachate could flow with precipitation to the rock and storm water inlet (blue circle).

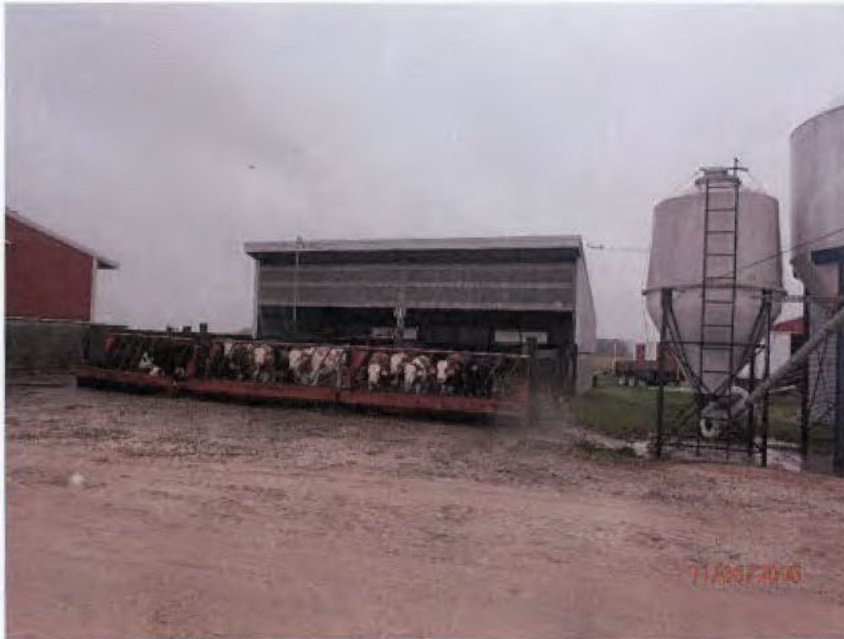
8: PB060010

EPA observed the open pen in front of the Open Front Heifer Barn and noted that there was no containment for the manure and process wastewater at the southeast corner. EPA observed the runoff flow from this pen to the north. EPA also observed a pile of uncovered silage just south of Building 29.

Description: Open Front Heifer Barn (Building 28) has no containment for manure and process wastewater from the southeast corner of the open pen.

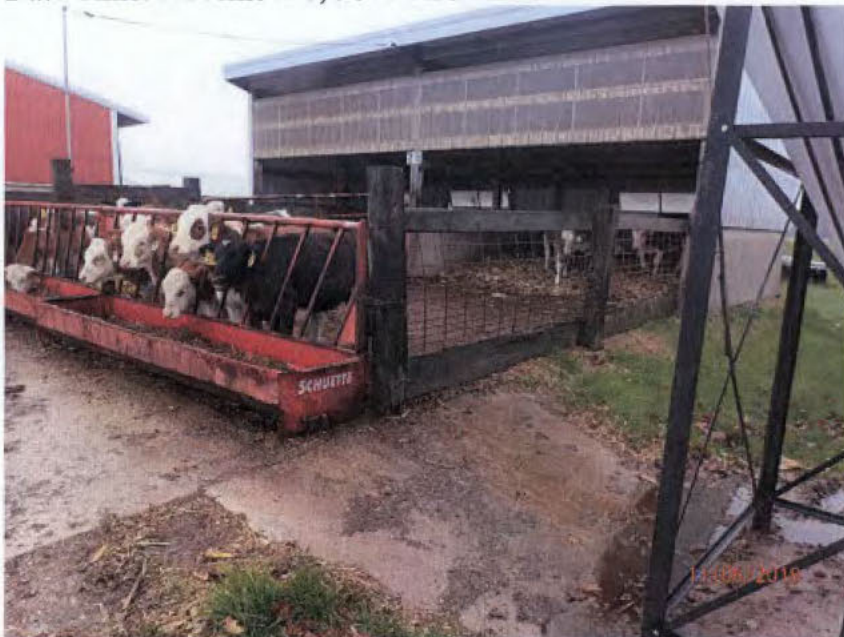
9: PB060011

Description: Open Front Heifer Barn has no containment for manure and process wastewater from the southeast corner of the open pen.

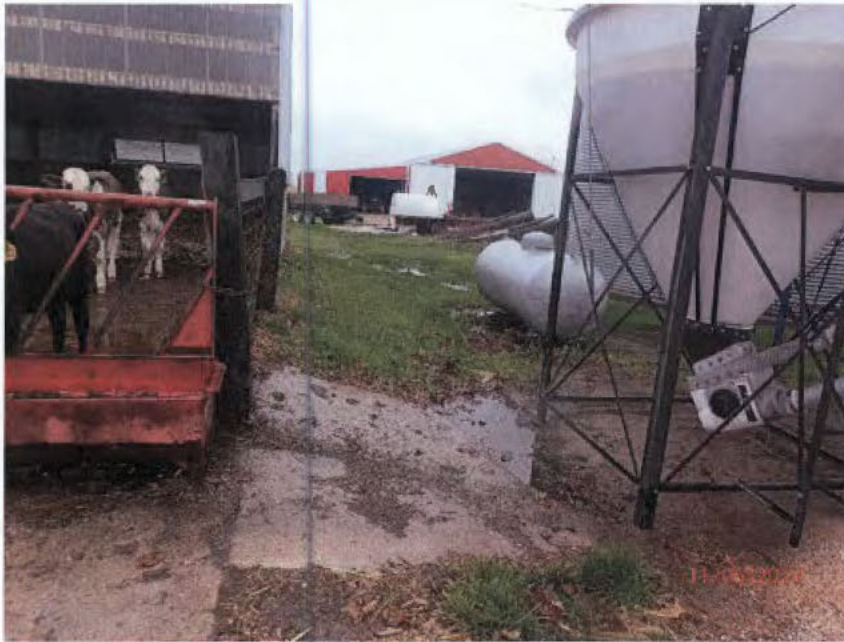
10: PB060012

Description: Manure and process wastewater from the Open Front Heifer Barn pools to the east and flows with precipitation to the north.

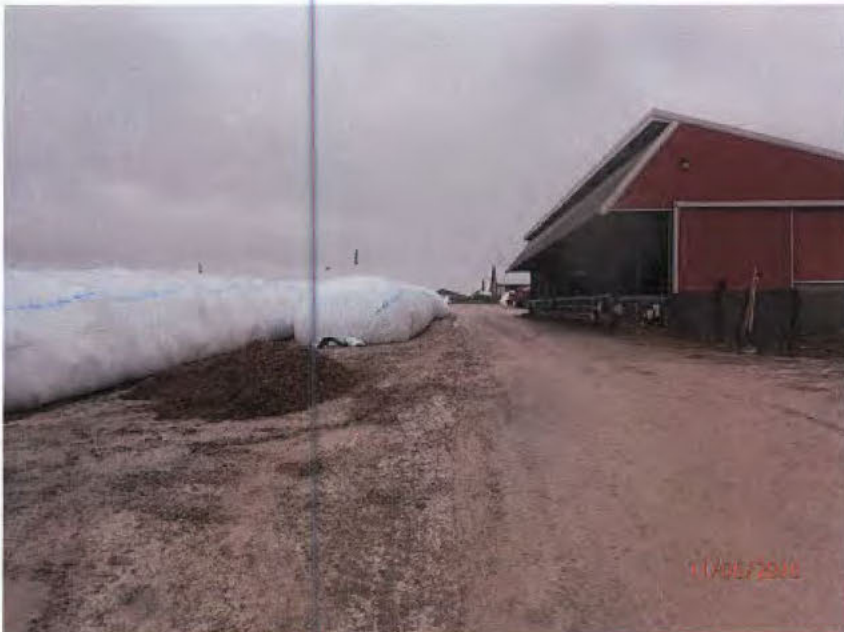
11: PB060013

Description: Pile of silage in the open. Concrete solids bunker is to the right in the photo.

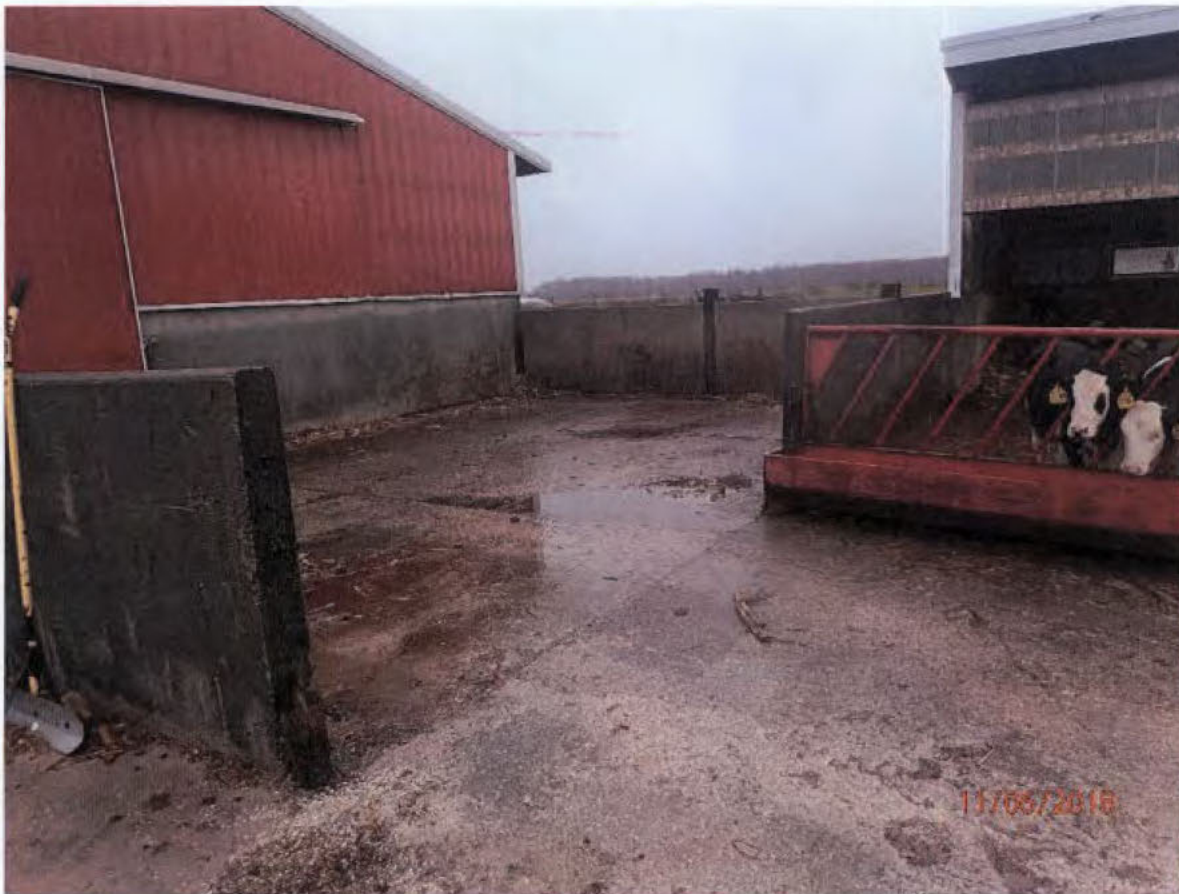
12: PB060014

Description: There is no containment for manure and process wastewater from the solid stacking area east of the Open Front Heifer Barn. Precipitation could carry manure and process wastewater out of the area and to the east and then to the north.

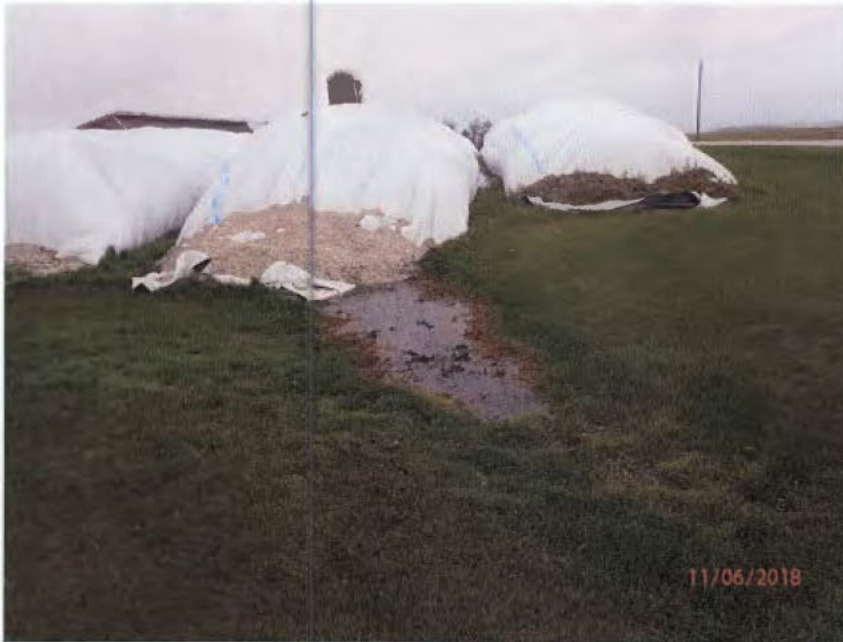
13: PB060015

Continuing along Sandy Bay Road to the west, EPA observed a pool of black liquid on the west side of the same silage bags. The vegetation appeared nutrient burned. Just to the west of the pool of liquid, EPA noted that there was a culvert to allow flow to go west under the facility driveway. Just west of the driveway, there was an inlet pipe. Later, the facility owner stated that the inlet pipe was for storm water and it was piped underground to the north and outlet at the intermittent unnamed tributary. Although EPA did not observe the liquid flowing through the culvert and to the inlet pipe on the day of the inspection, with precipitation, the liquid could flow there. The ground from the pool of liquid to the culvert was saturated.

Description: A pool of black liquid on the west side of the silage bags along Sandy Bay Road.

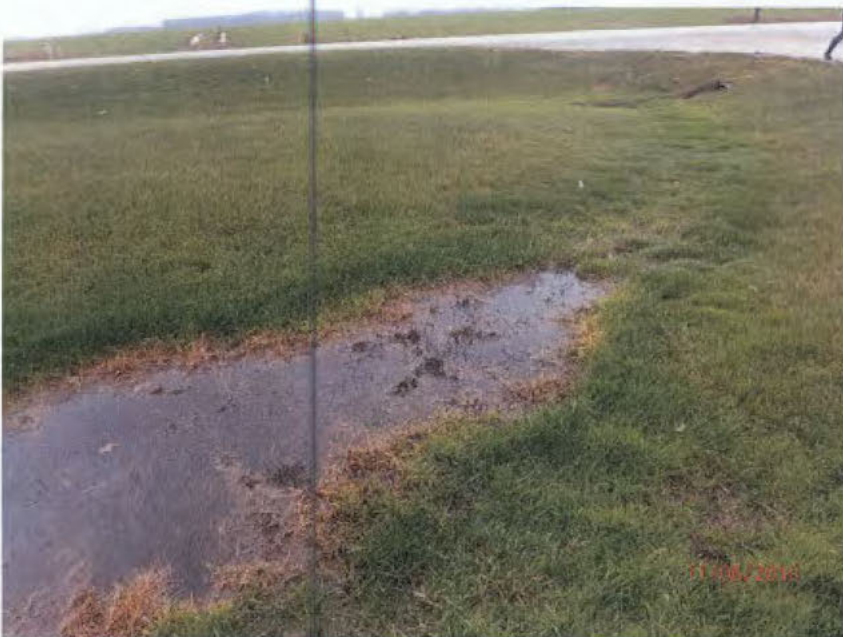
14: PB060016

Description: Liquid from the pool could flow to the culvert under the driveway and to a storm water inlet pipe on the other side of the driveway.

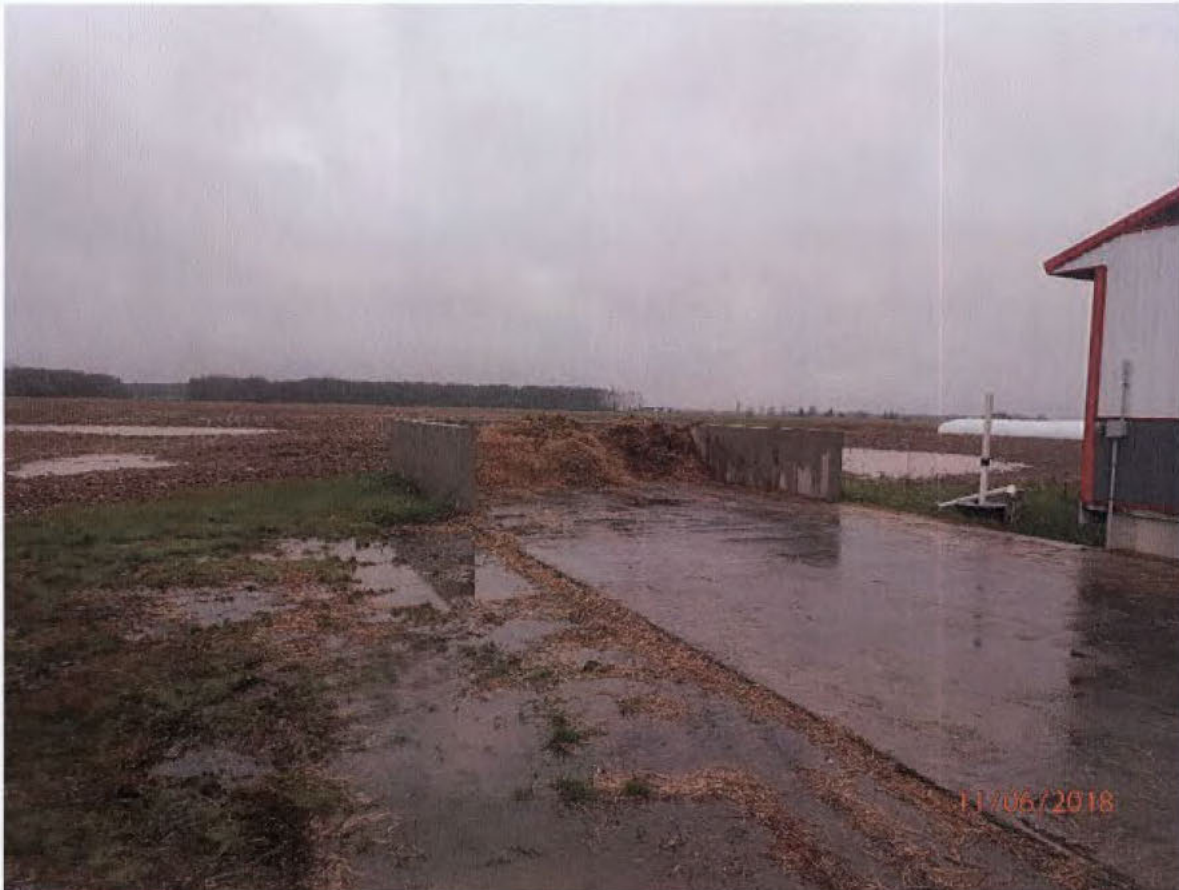
15: PB060017

EPA continued to the west and on the south side of the new Calf Barn. On the west side of the Calf Barn there was a concrete bunker for solids stacking. The walls were only installed on the northern end of the concrete pad. EPA observed used bedding off the concrete pad.

Description: Solids stacking area on the west side of the Calf Barn. There is some solids around the bunker that are not contained.

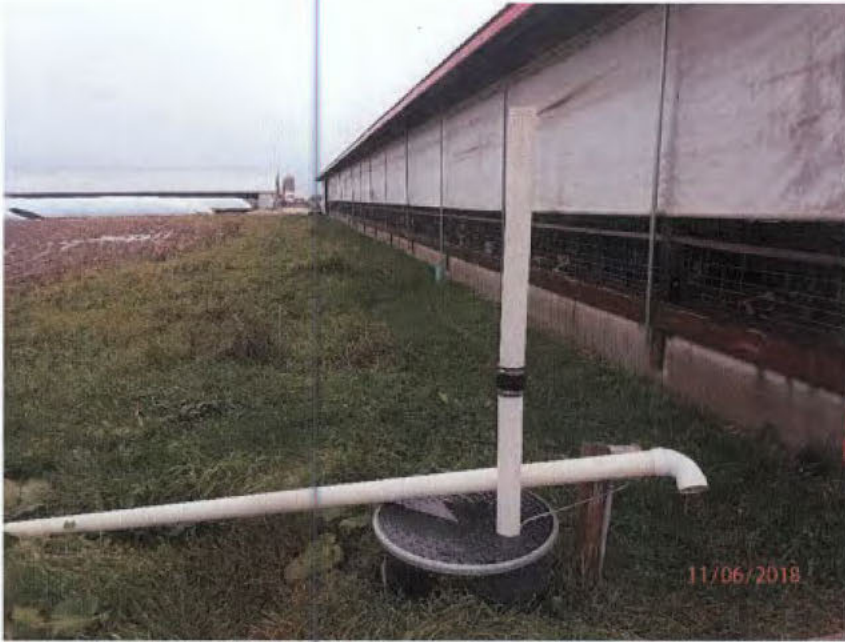
16: PB060018

Next to the concrete bunker, there was a tank and piping. Later, the facility owner stated that the tank accepted milk house waste and it was mixed with the solids from the bunker and land applied almost daily.

Description: Tank collects milkhouse waste and is land applied with the solids that are stacked in the solids stacking area west of the Calf Barn.

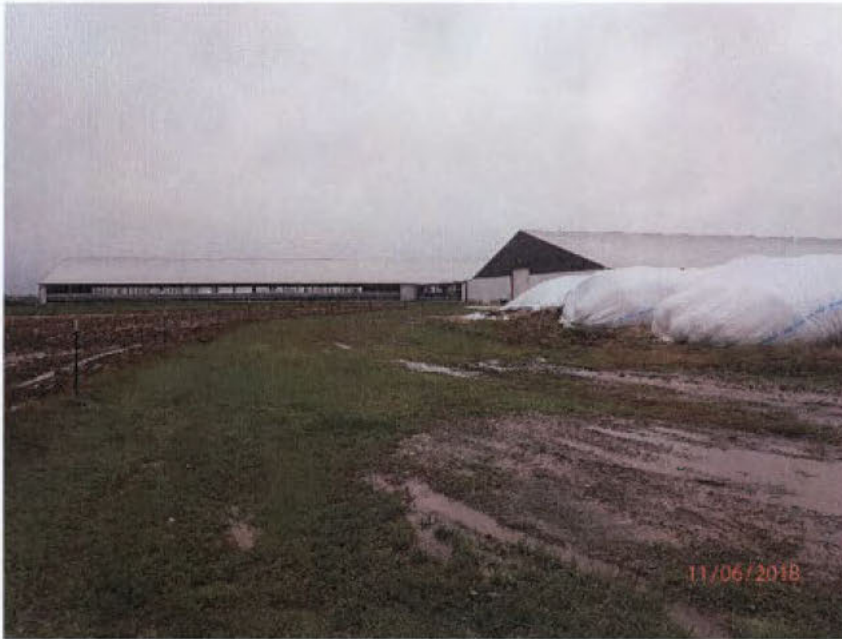
17: PB060019

Description: Silage bags between Calf Barn and Barn #2.

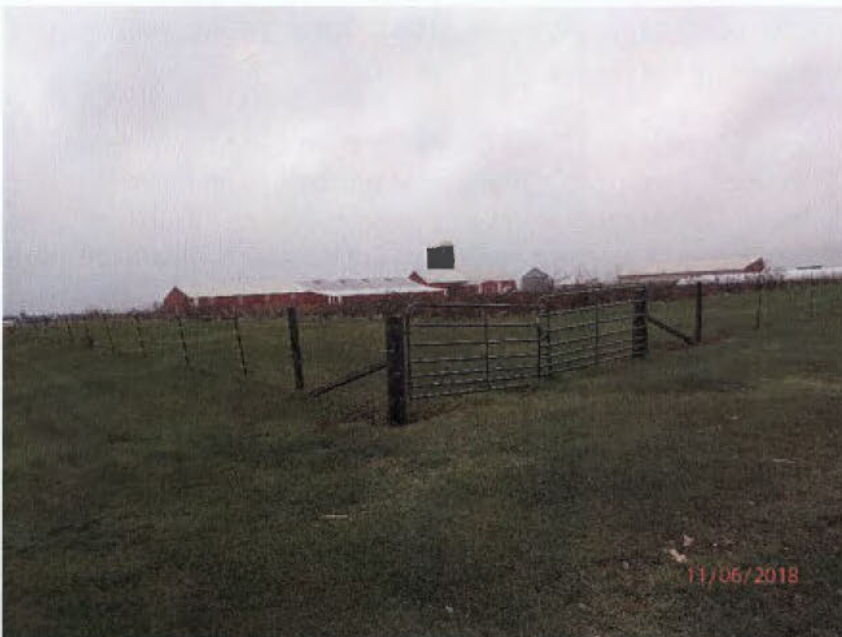
18: PB060020

Description: Fencing around the Manure Pond.

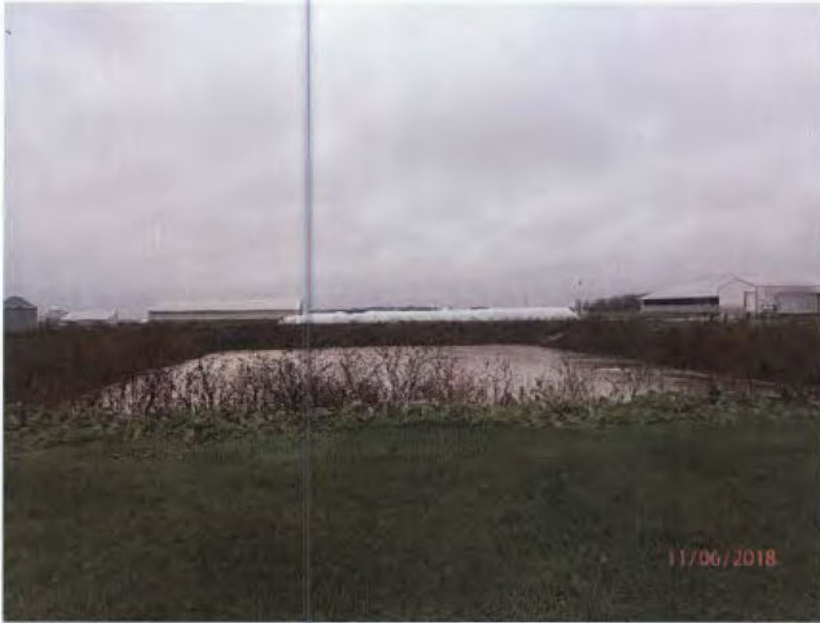
19: PB060021

EPA then walked east along the north side of Barn #2 and the Parlor Barn and Manure Pond. EPA noted that there was more than five feet of freeboard in the Manure Pond and there was some woody growth in the inside berm. The Manure Pond was protected by an electrified fence and EPA did not observe any depth markers. Later, the facility owner confirmed that there were no depth markers installed in the Manure Pond.

Description: There are no depth markers in the Manure Pond, but there is more than two feet of freeboard.

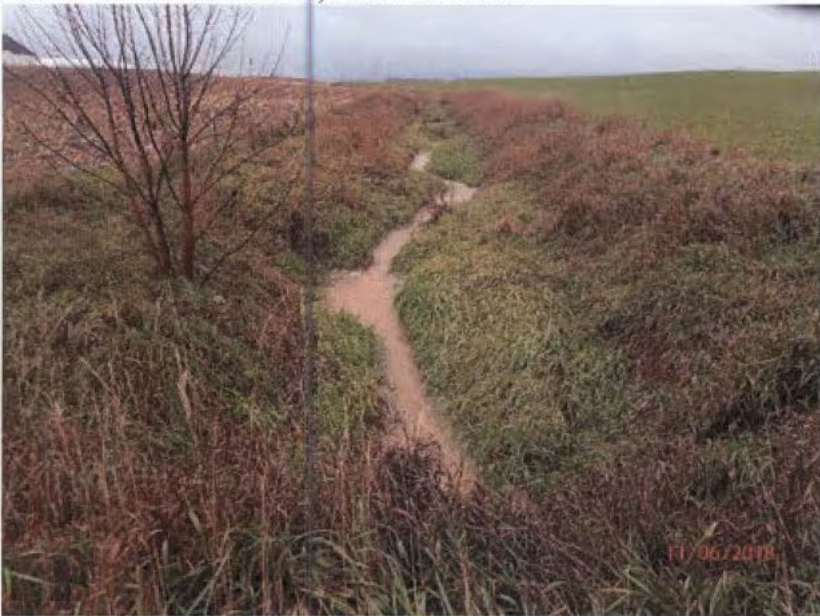
20: PB060022

Description: Looking upstream at the consistent flow in the intermittent unnamed tributary north of the facility.

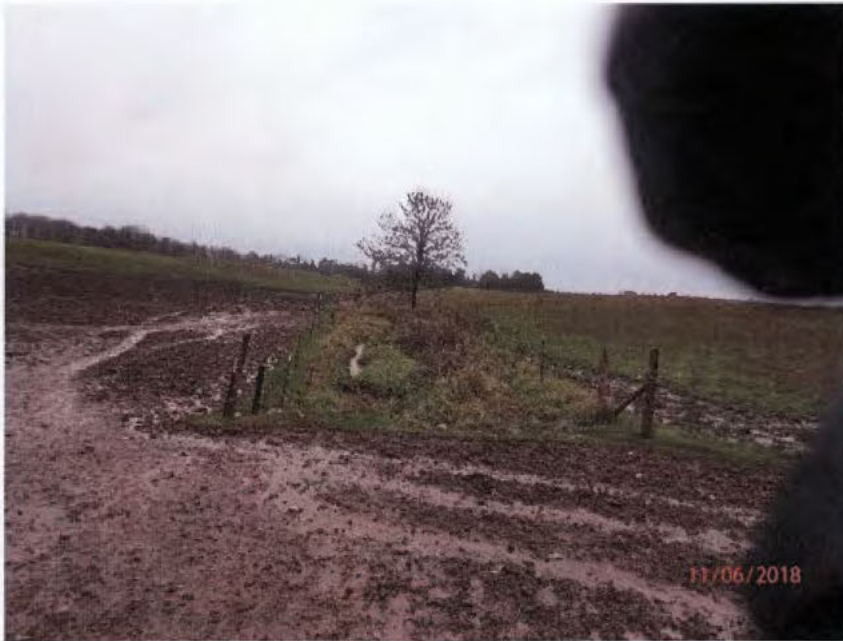
21: PB060023

Description: Looking downstream at the intermittent unnamed tributary north of the facility. Note the lack of vegetation in the Cattle Walkway (foreground) and Feedlot (left side of photo).

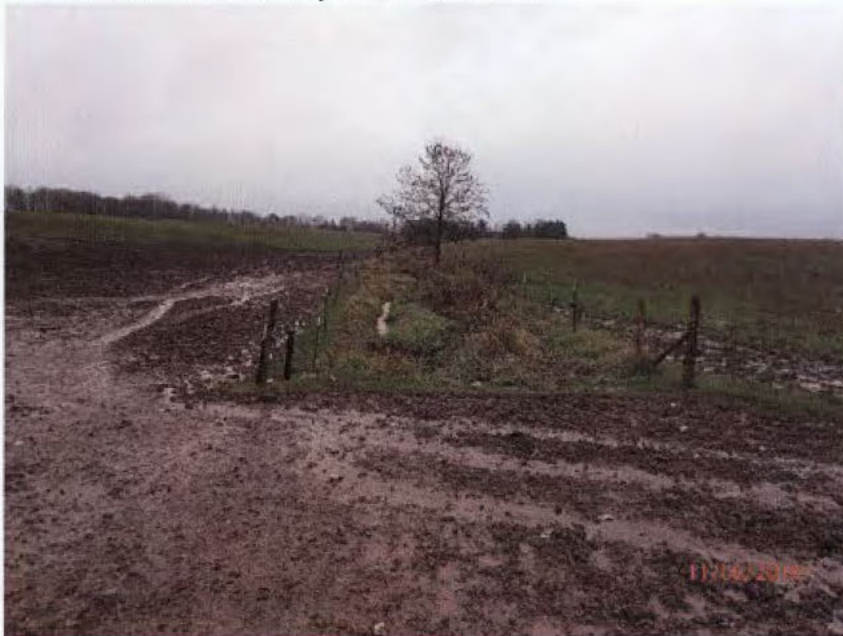
22: PB060024

Description: An electrified fence prevented EPA from crossing the Cattle Walkway.

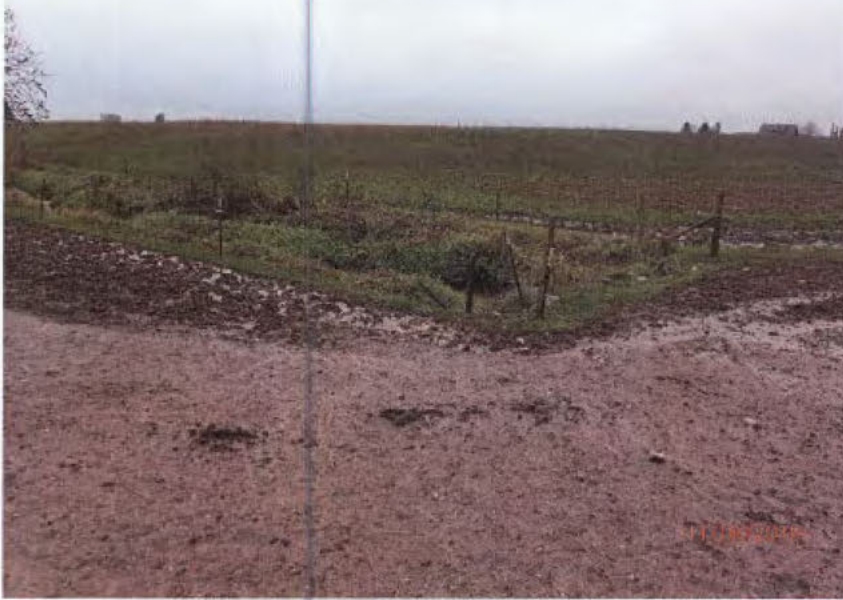
23: PB060025

Description: No containment for the manure and process wastewater from the Cattle Walkway to the intermittent unnamed tributary.

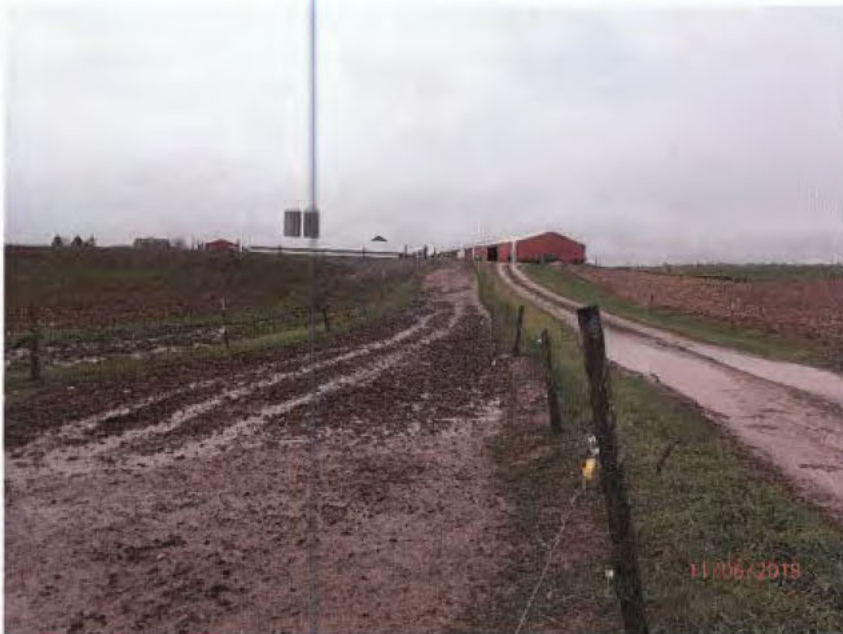
24: PB060026

Description: Cattle Walkway to the Feedlot.

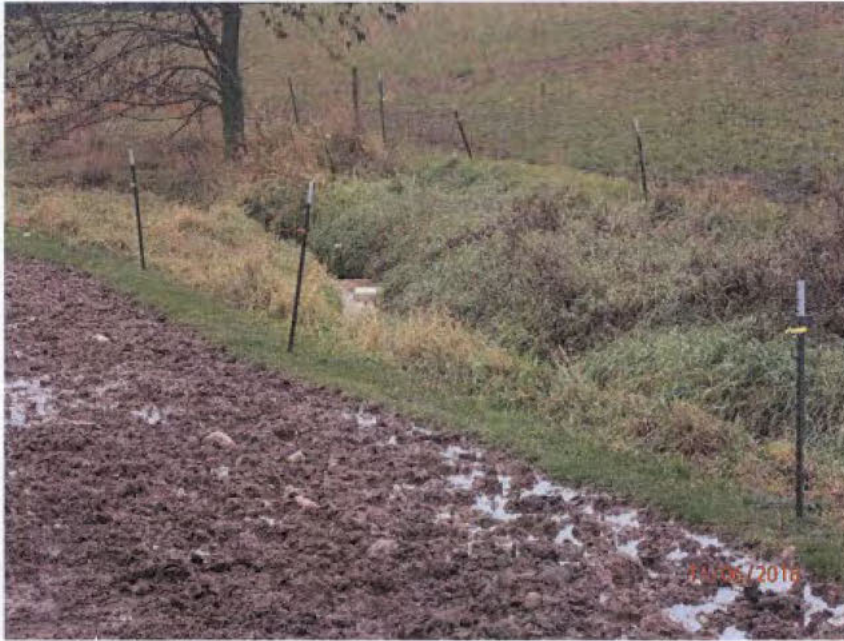
25: PB060027

Description: Pipe discharges liquid from unknown source to the intermittent unnamed tributary. Note that there is no vegetation in the Feedlot all the way to the fence line.

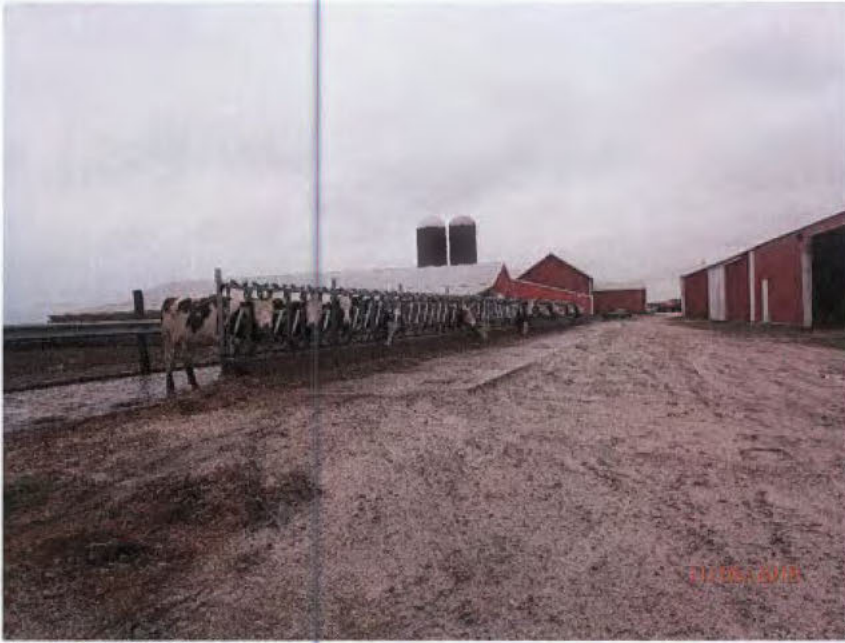
26: PB060028

EPA walked to the south up the facility driveway toward the Machine Shed. Just to the east of the Machine Shed, EPA observed a feed alley that was exposed to the elements. Process wastewater from the feed alley could flow with precipitation downhill to the north and to the intermittent unnamed tributary.

Description: Cattle are fed on an open feed alley. Process wastewater from here would flow to the north with precipitation.

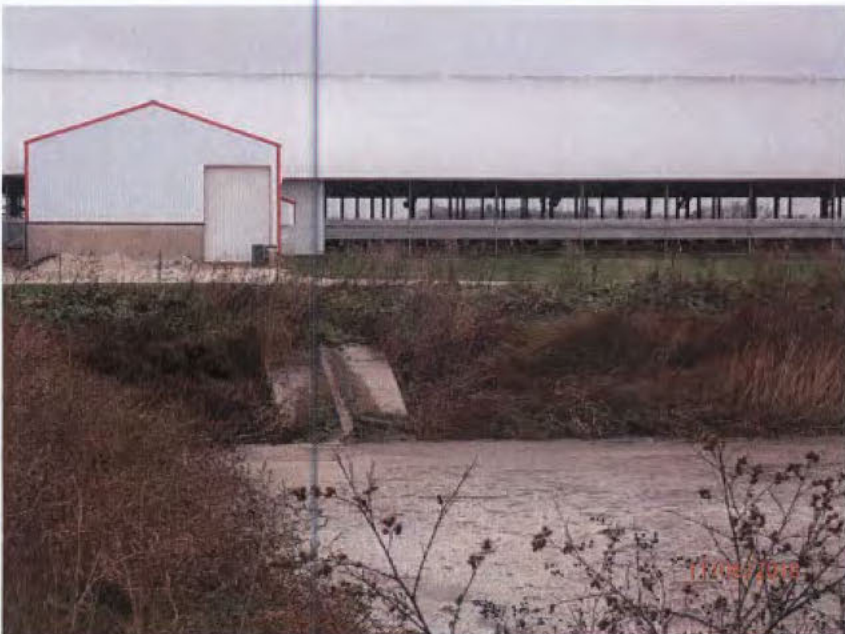
27: PB060029

EPA then walked to the south between the Machine Shed and the Manure Pond and observed liquid manure entering the Manure Pond at a concrete ramp at the southwest corner.

Description: Concrete ramp at southwest corner of the Manure Pond for liquids to enter the pond.

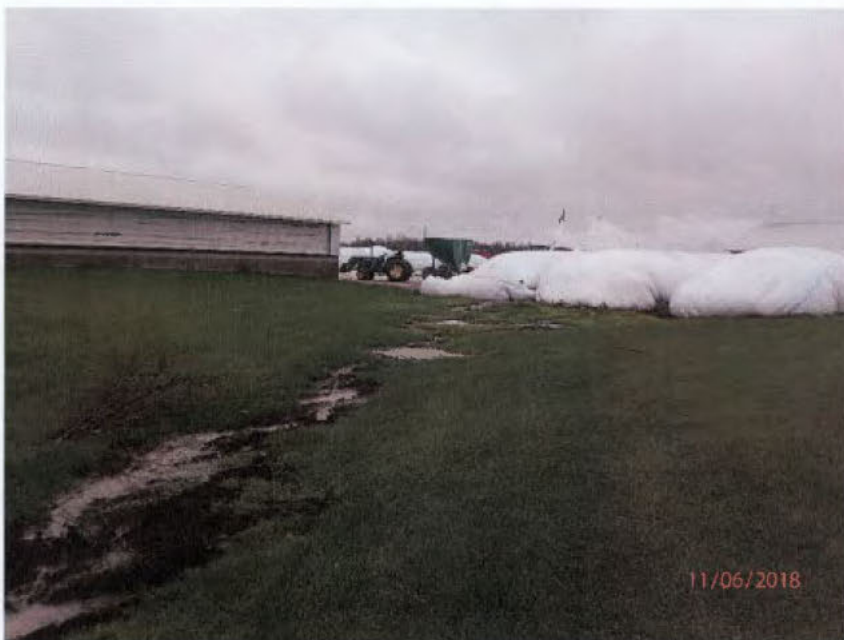
28: PB060030

EPA continued to the south and observed silage leachate coming from silage bags stored south of the Manure Pond. There had been approximately $\frac{3}{4}$ " of rain the night before and there was a distinct pathway of liquid, although not continuous, along the ground between the Machine Shed and the Manure Pond, going to the north. The vegetation appeared nutrient burned in the pathway and the liquid was cloudy.

Description: Discharge pathway from silage bags flows to the north.

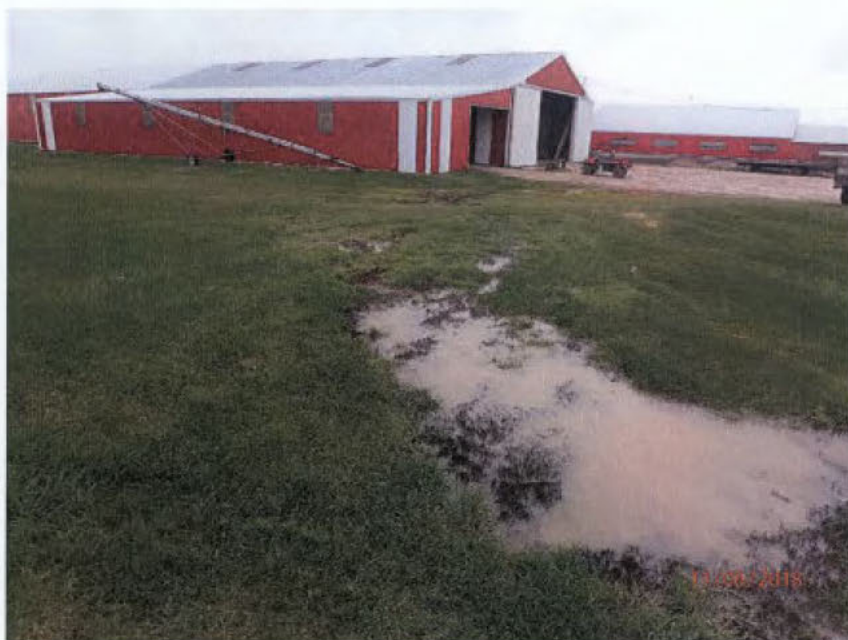
29: PB060031

Description: Continuation of the flow pathway from the silage bags.

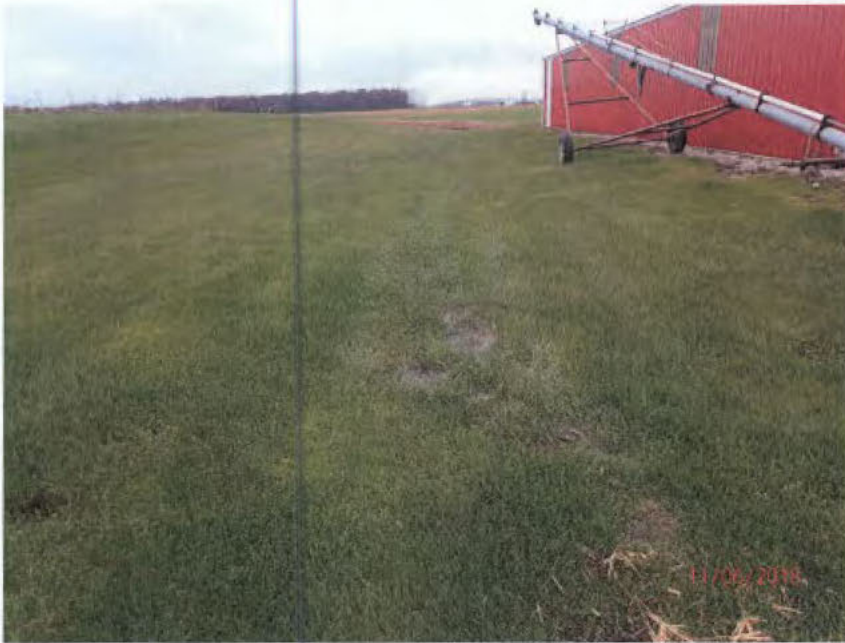
30: PB060032

Description: Continuation of flow pathway from the silage bags. Flow is not continuous, but soil is saturated.

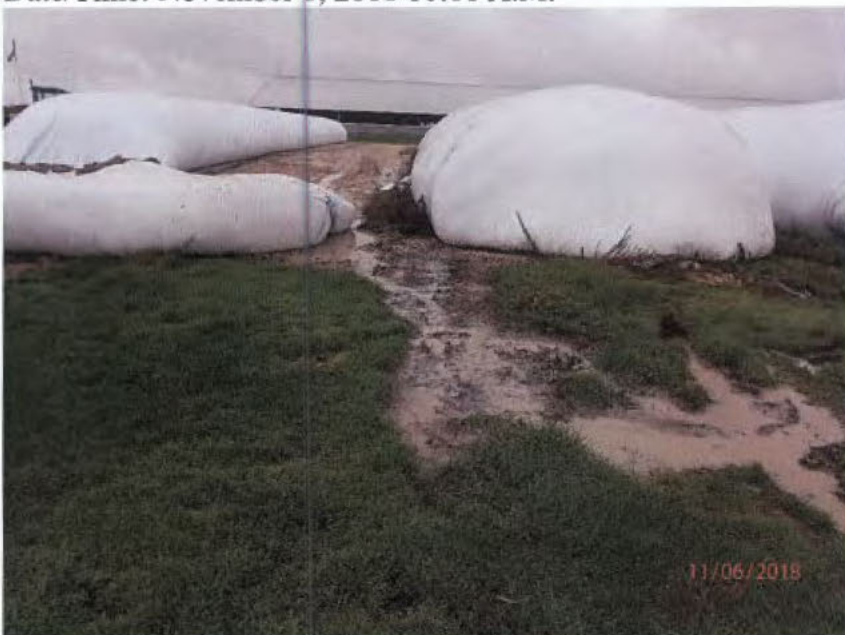
31: PB060033

Description: Process wastewater from the silage bags west of the Open Front Heifer Barn. This is the beginning of the flow pathway photographed in the previous three photos.

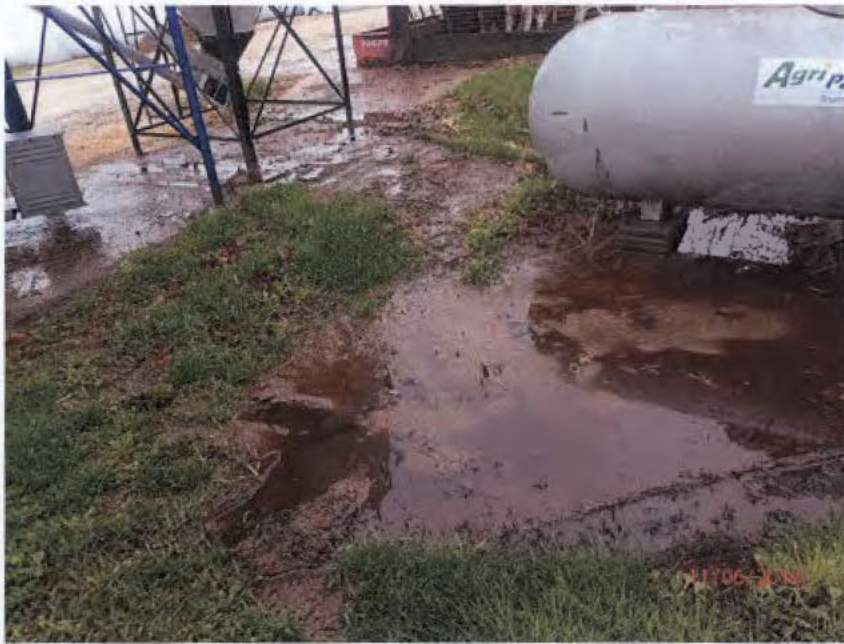
32: PB060034

EPA also observed the manure and process wastewater from the southeast corner of the open pen of the Open Front Heifer Barn channelized and flowed to the north. Although not continuous, this pathway would eventually join the pathway from the silage bags and the combined flow would go to the north. With precipitation, this flow could reach the intermittent unnamed tributary just north of an ag field. The soil was saturated in the flow pathway.

Description: Discharge pathway from open pen of the Open Front Heifer Barn.

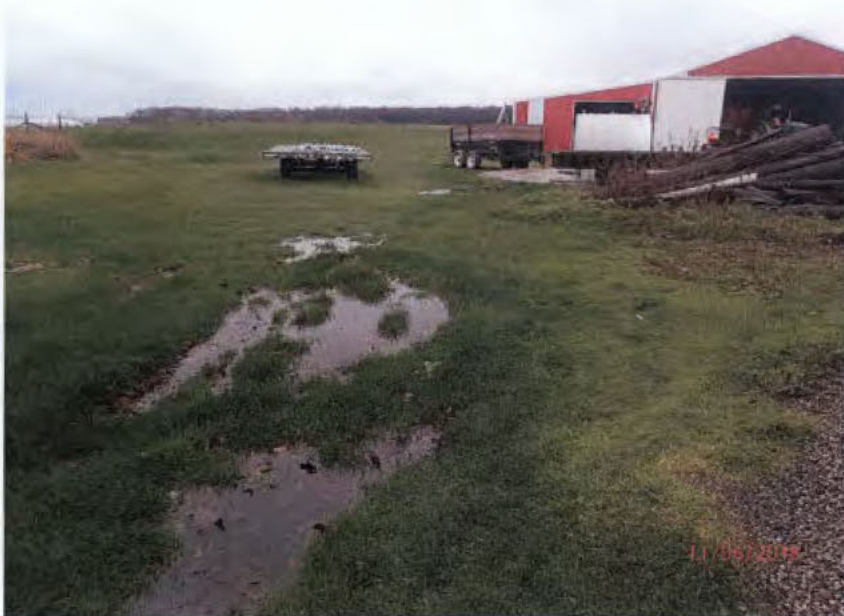
33: PB060035

Description: Flow pathway from the open pen of the Open Front Heifer Barn flows to the north.

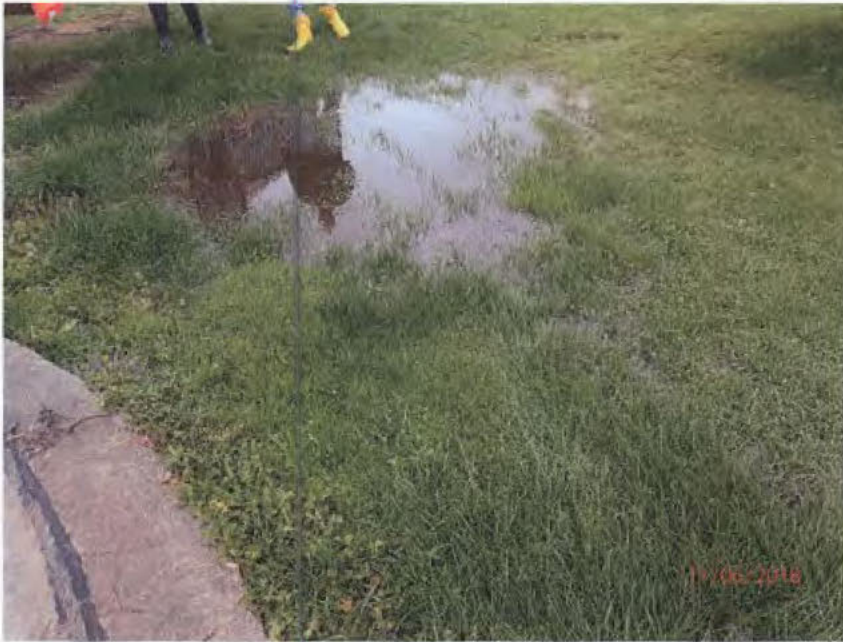
34: PB060036

Description: Flow pathway from the open pen of the Open Front Heifer Barn continues to the north. Even though it wasn't continuous, the ground was saturated.

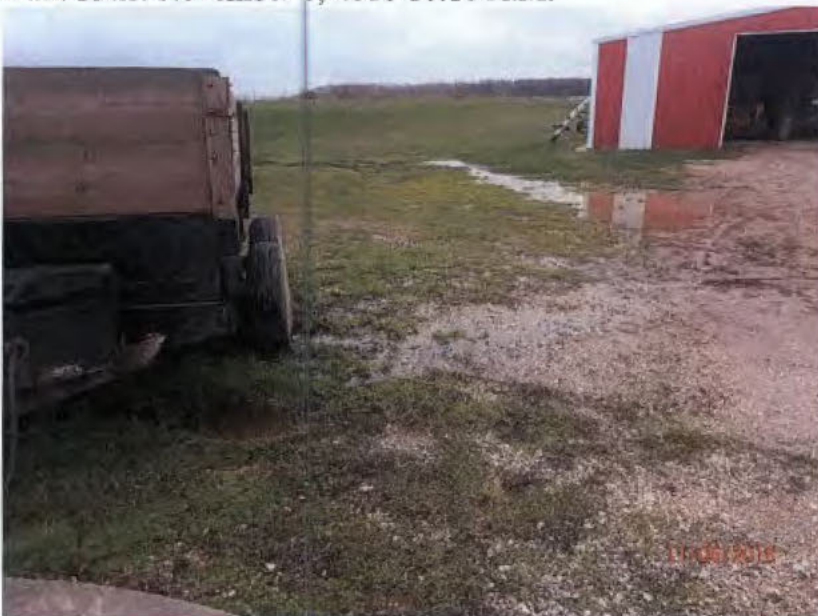
35: PB060037

Description: Flow pathway goes on the west side of silo base and then under the cart and then to the north. The flow from the open pen of the Open Front Heifer Barn joins with the flow pathway from the silage bags to the west of the Open Front Heifer Barn.
